HAGERSTOWN LANDMARKS RECONNAISSANCE SURVEY

Maryland Inventory of Historic Properties # WA-HAG-191

Property Name/Address: Miller's House, Hager Park, Hagerstown, Maryland

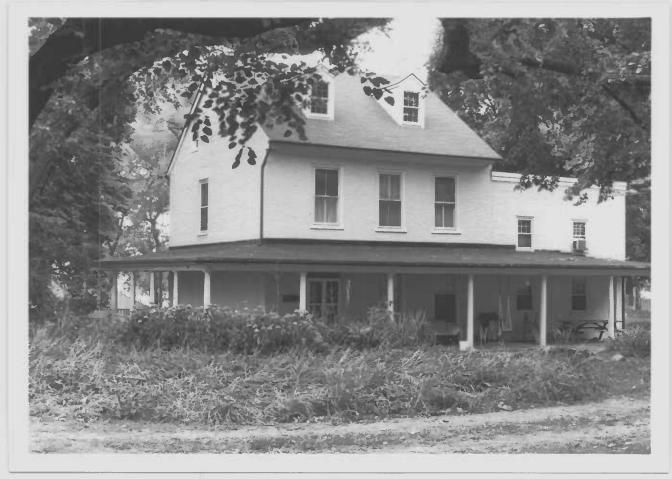
MILLER'S HOUSE

VIEW YROM HONTHUEST

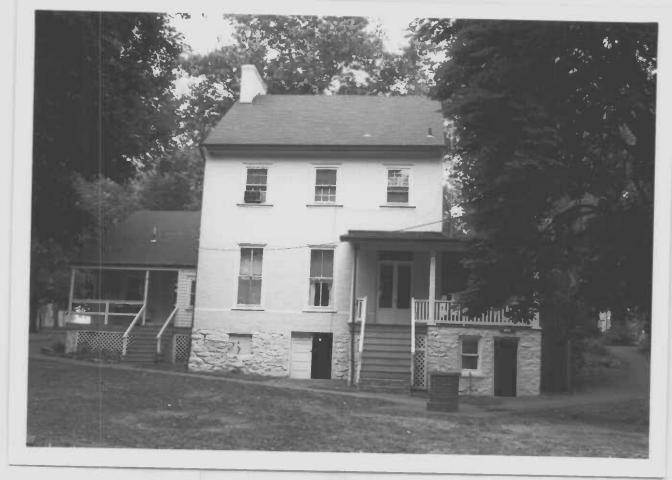
MA-VAG-191
MILLER'S HOUSE
HAGERSTOWN, MD
191 P. KURTZE
EAST FACADE

The building known as the Miller's House is a $2\frac{1}{2}$ story, gableroofed, side passage plan painted brick dwelling dated 1791. three-bay-wide principal facade faces east and is constructed of brick laid in Flemish bond, with a quarter-round water table of molded brick above a raised limestone foundation. The entrance, located in the northernmost bay, has a four-light transom above a replaced door. An early 20th century Colonial Revival porch spans the entrance bay, wraps around the north gable, and continues across the west elevation. The other first-floor bays hold tall two-overtwo sash (installed in the course of a late 19th century remodeling, in which the window openings were lengthened by lowering the sills to the level of the water table). The window openings retain splayed jack arches, two brick-lengths high. A cellar entrance (the opening has been reworked) is located below the central bay; to the left of this entrance is a blocked cellar window with a brick jack arch. On the second story, six-over-six sash survive in original pegged frames with backband trim, surmounted by rubbed brick jack arches. second story windows also retain projecting molded sills with coved subsills. The east facade is capped by a complex cornice with bed and crown moldings. The roof is covered with brown asphalt or fiberglass shingles; there are no dormers on the east slope.
